COMMENT TO THE STB BY MICHAEL A. TRUJILLO 1/17/2010
ENTERED
Office of Proceedings

28 West 5th Avenue, Antonito, Colorado

I will speak particularly to the condition of the bridges, the irrigation ditch bridges, the materials used for construction, the culverts, railroad crossings, maintenance and wetlands.

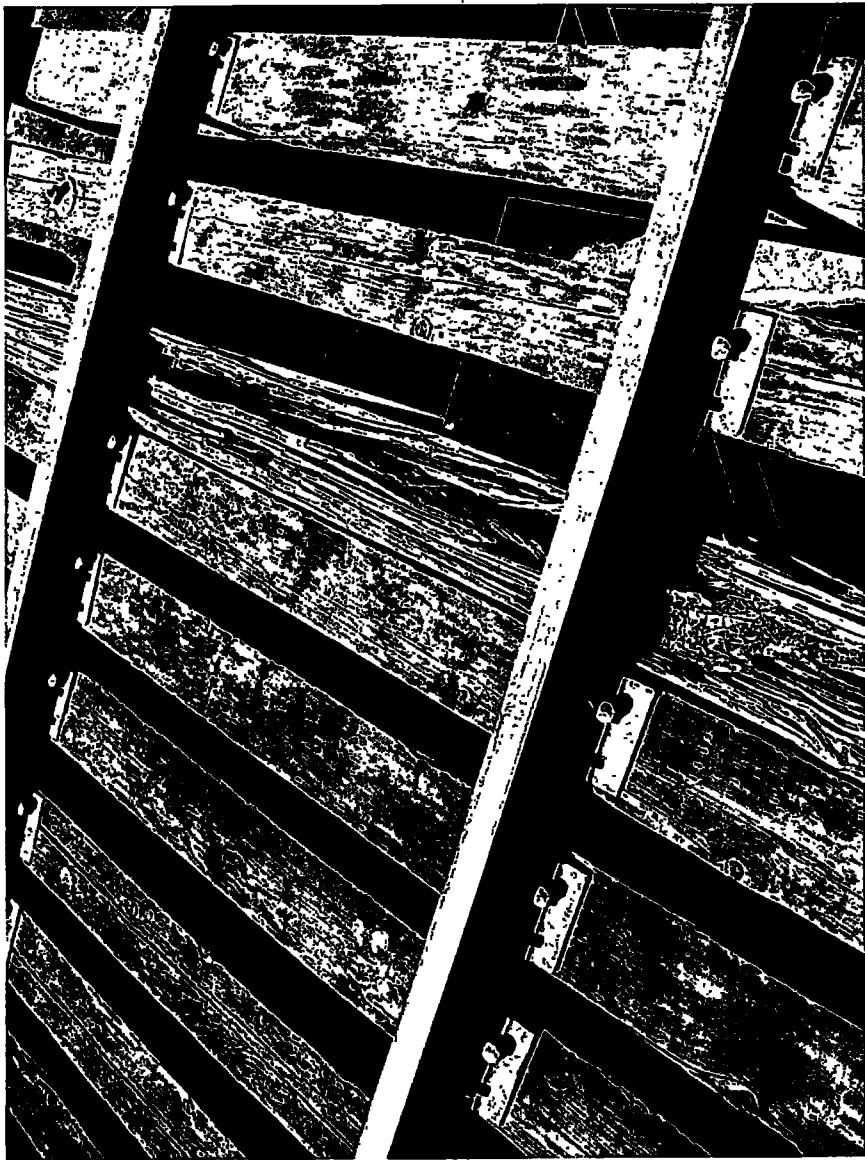
This photo of the top of the San Antonio Bridge shows at least one tie that obviously has to be replaced. The mere fact that it is misaligned, lacks spikes, lacks tie plate, and is not consistent with the given 8 inch spacing, may give a hint as to whether or not it should be replaced. Also, it should be noted that the San Antonio River is vulnerable to any aspect of the operation of the railroad, as static "green water" can be noted below.

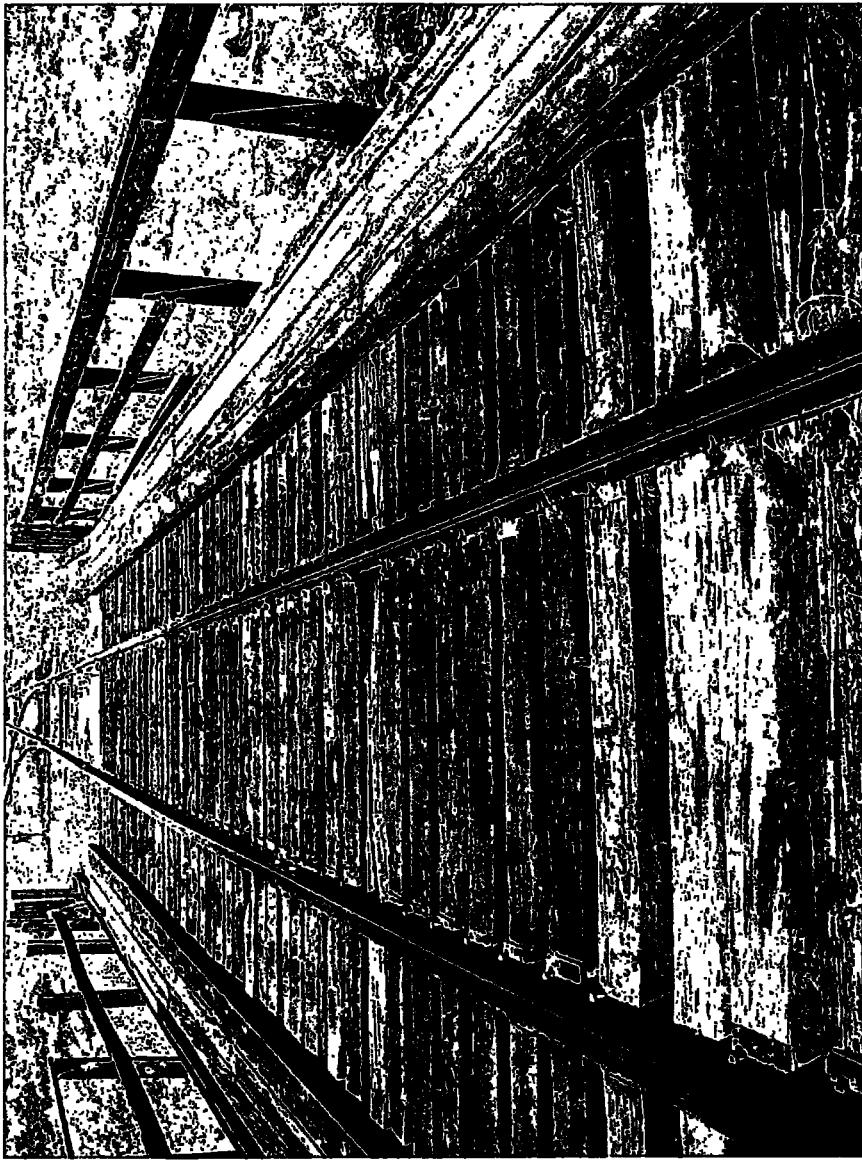
Top view of the San Antonio Bridge

Catwalks are indicated on either side of the rail head and are 3 feet wide by 54 linear feet long. While the catwalks may carry no functional value, they reflect the lax maintenance and the current condition of the bridge.

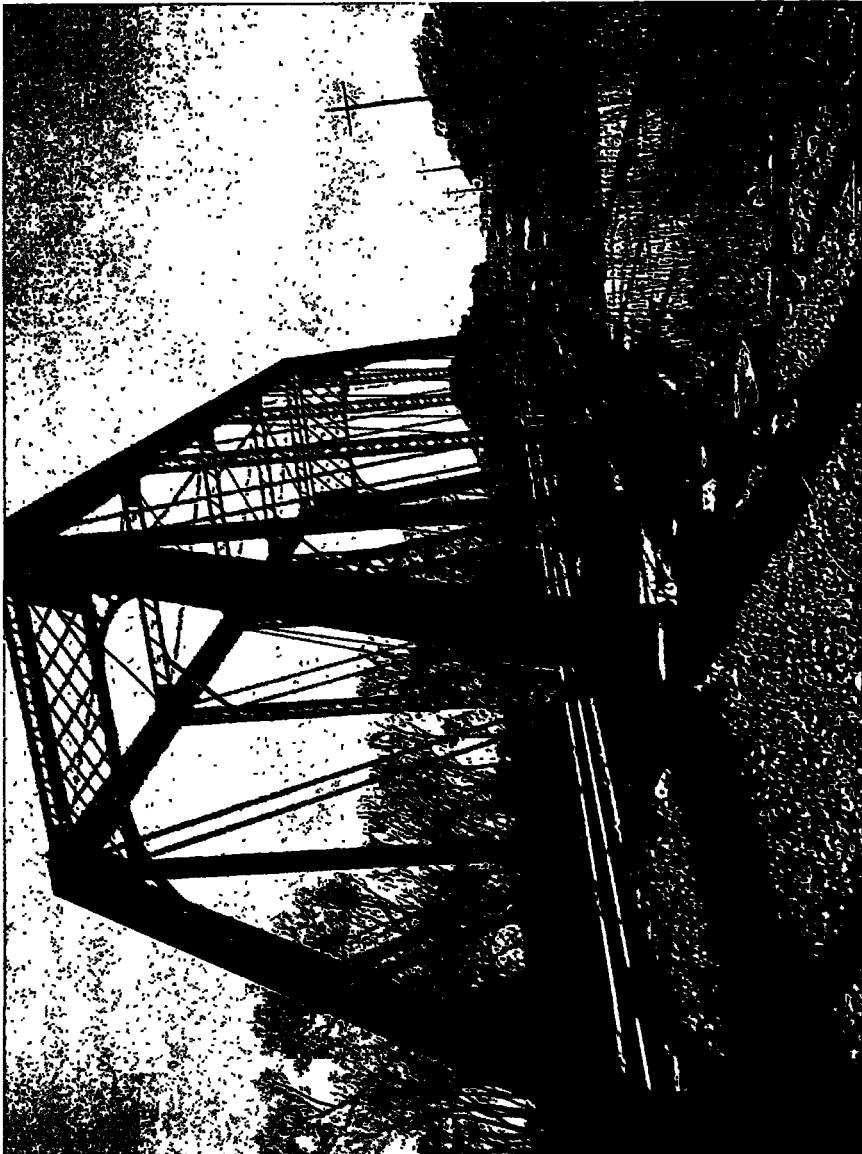
THE CONEJOS BRIDGE NO DATE OF CONSTRUCTION NO WEIGHT CAPACITY

The most telling feature in this photo is the lack of any literature to suggest what the loading capacity is on the Trussed RR Bridge situated at N 37 degrees 06'05" W 105 degrees 00'24". Elevation here is 7857 feet above sea level. The bridge is 10' wide at the top by approximately 60' long. A bridge of similar design approximately 8 miles East on COHWY 142 was discontinued by the State of Colorado back in the 70s because of some loading malfunctions. A significant event that currently occurs is the situation of the bottom cord running well over 130 feet on either side of the river resting on what could be Basalt or Granite. In either case, it appears that the weight of the bridge alone plus that of superimposed loads could possibly alter the structural integrity of the bearing soil and loading points. Oxidation of metal appears to be in abundance, and for the sake of argument does not appear to be primed an/or painted for a substantial period of time.. Various railroad ties are in the state of requiring at least some maintenance or repair.

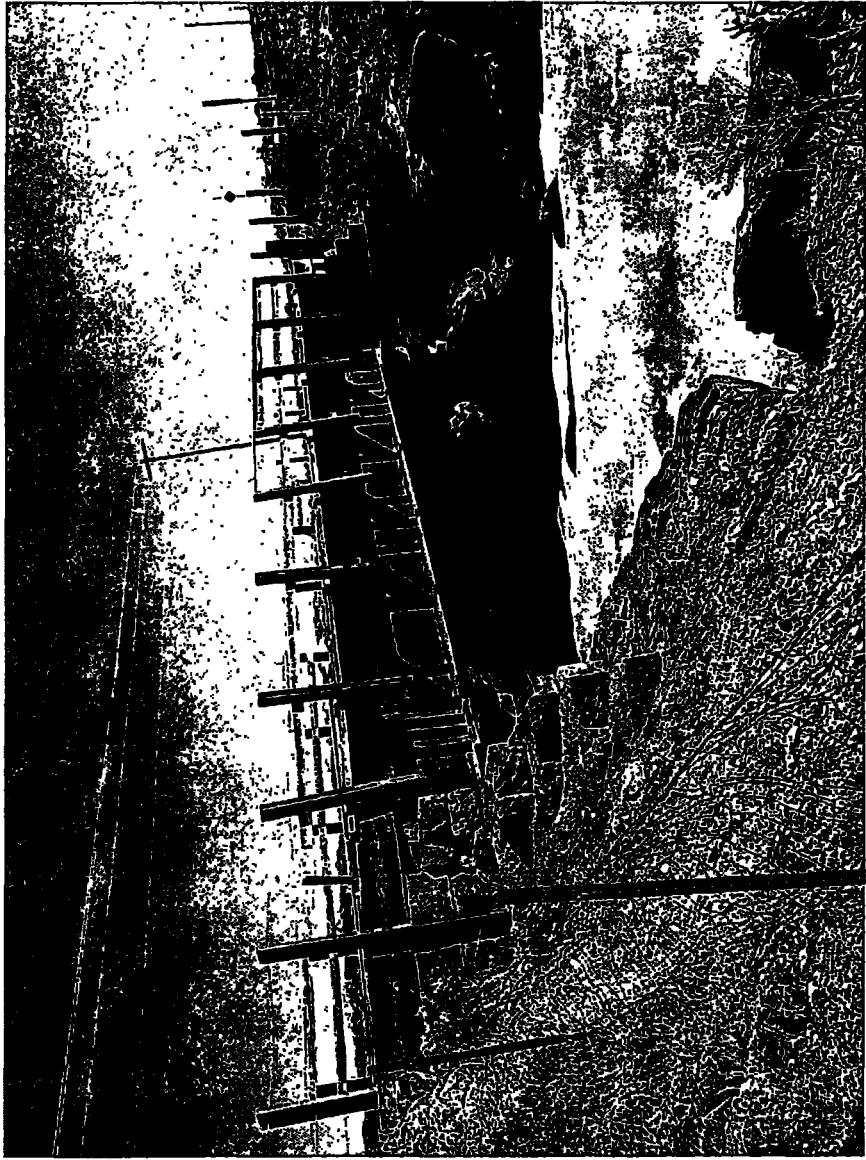
San Antonio Bridge (west perspective) situated North 37 degrees , 03 minutes ,52 seconds, West 160degrees , 00minutes, 25 seconds. Bridge runs North and South and rests at each riverbank on a combination of basalt and bedrock. In some cases, concrete pads have been added to stabilize apparent previous failures of both the basalt and the bedrock. No loading capacity of bridge is noted in any area. Elevation: 7910ft above sea level.

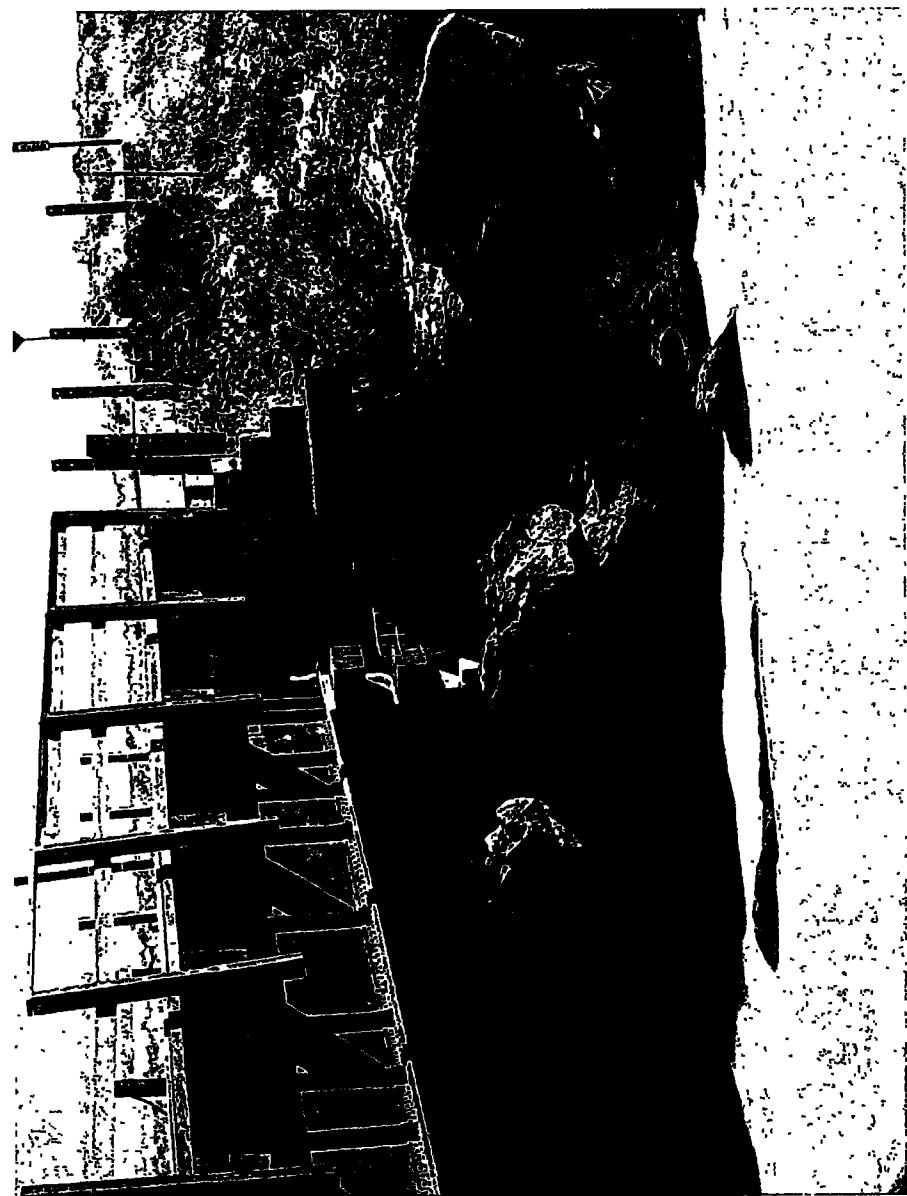
This photo shows a 3 foot times 16 inches times 8 inch thick concrete pad at the south base of the San Antonio Bridge. Creosote-treated soft wood material rests on concrete pad and also rests on bedrock, which possible was subjected to overbearing weight at one point in time .

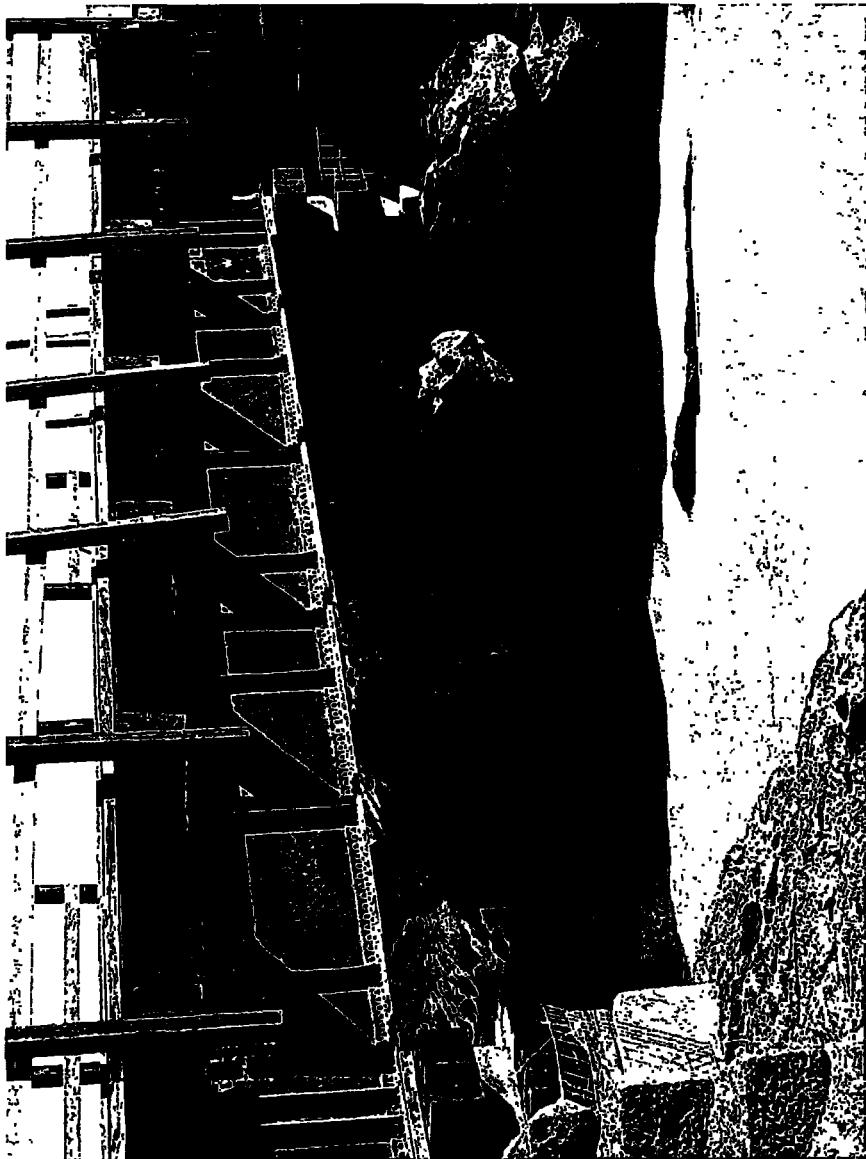
North and South perspective of the San Antonio River Bridge base, reflect the positioning of the 8 inch concrete pads in more detail. 8 inch x 8 inch soft wood rest on top of the concrete pads and wedges have been driven to apparently tighten the bond between the "I" beams and the soft wood material.

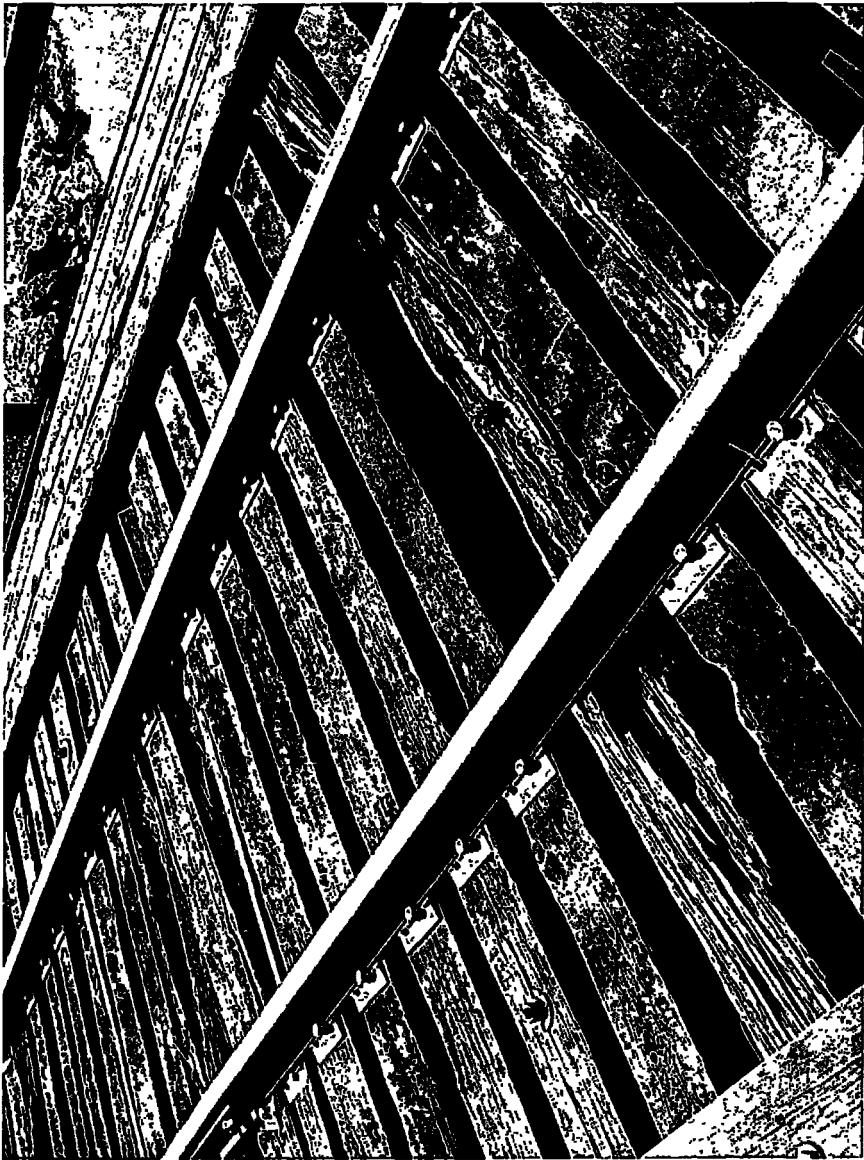
Top view of the San Antonio Bridge

This photo suggest that two spikes are allotted per each tie plate. Many circumstances indicate protruding spikes, misaligned tie plates and no indication that ties were pre-bored to receive single and/or not double spikes. Consequently several stress fractures are indicated in this photo—some to the extent that they currently serve no functional purpose.

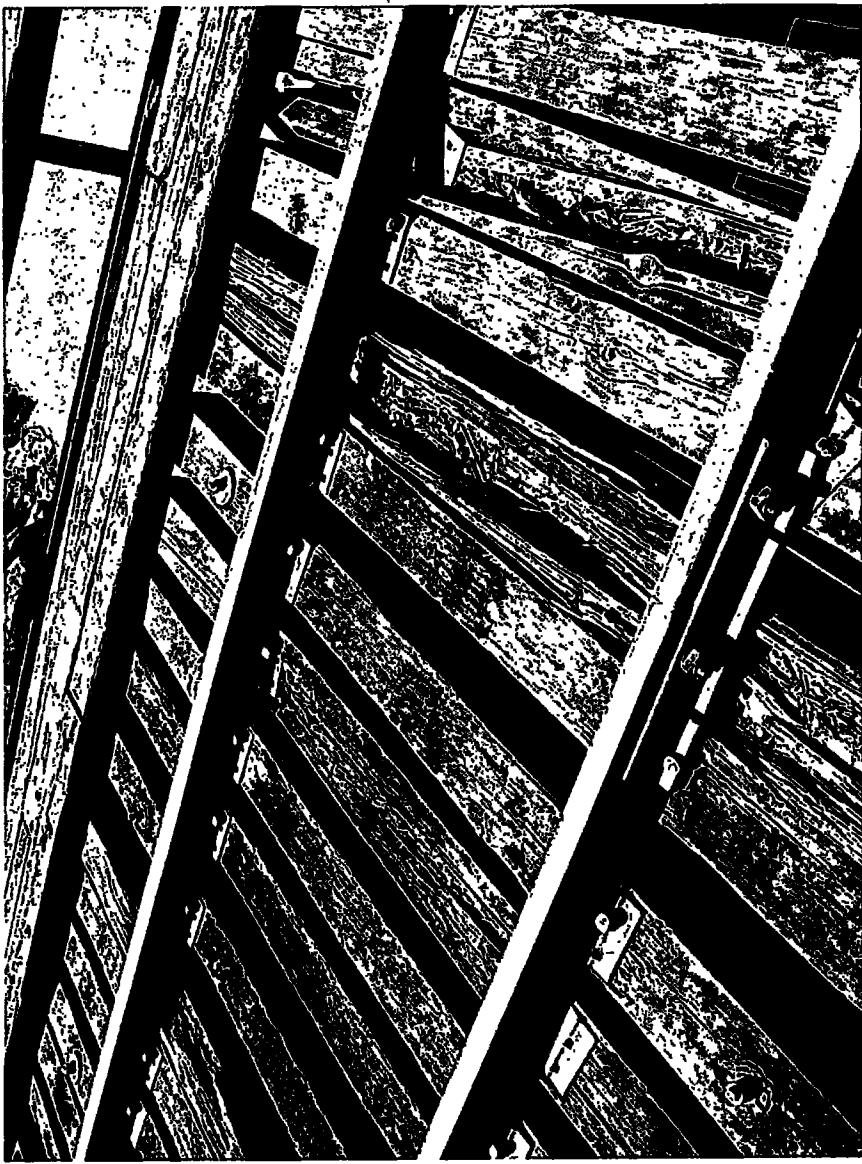
San Antonio Bridge, at the track top, reflects various railroad ties which obviously have to be replaced.

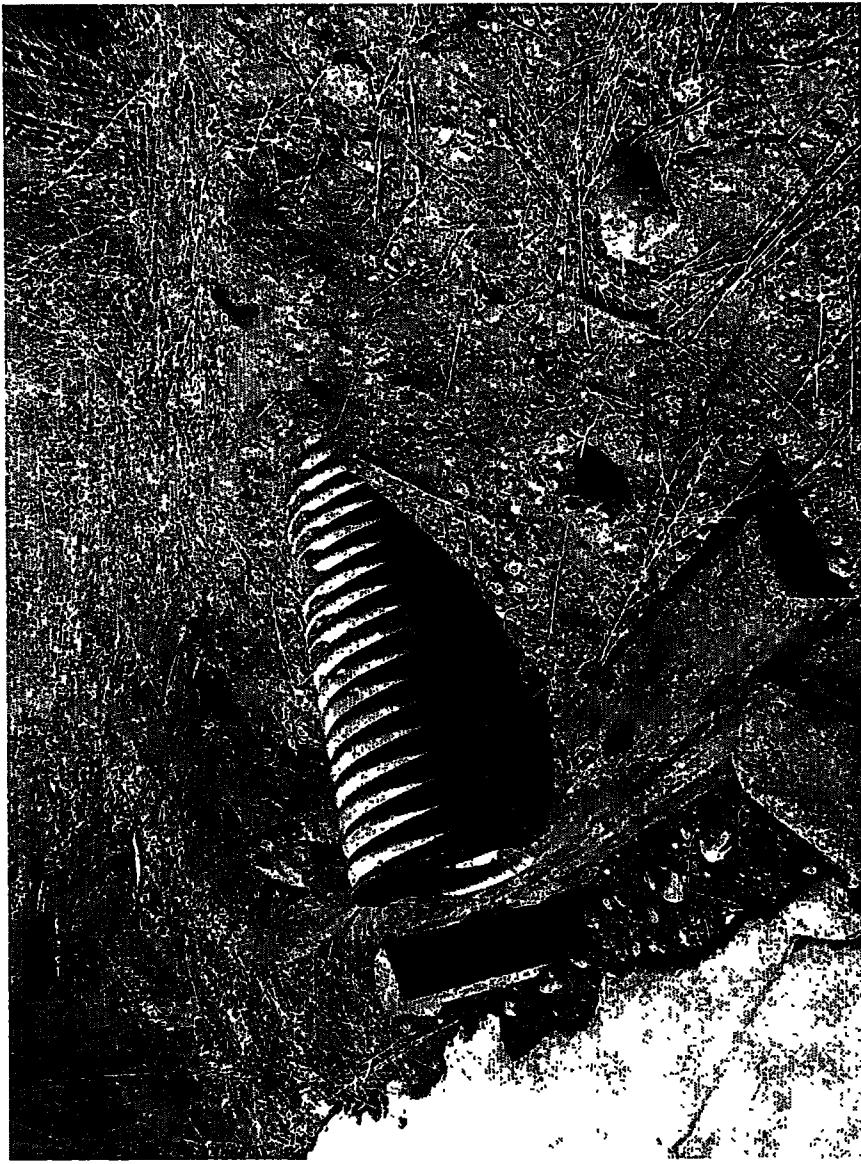
Again precariously placed storm water discharge culvert. Little regard given to the fact that these Creosote treated timbers will obviously be submerged in water this coming spring. In the meantime note that the walls and support systems deviate from the vertical. Metal stacks are expected to stabilize horizontally placed timbers which possibly act as a retaining wall to shore up existing disturbed soil and some ballast material.

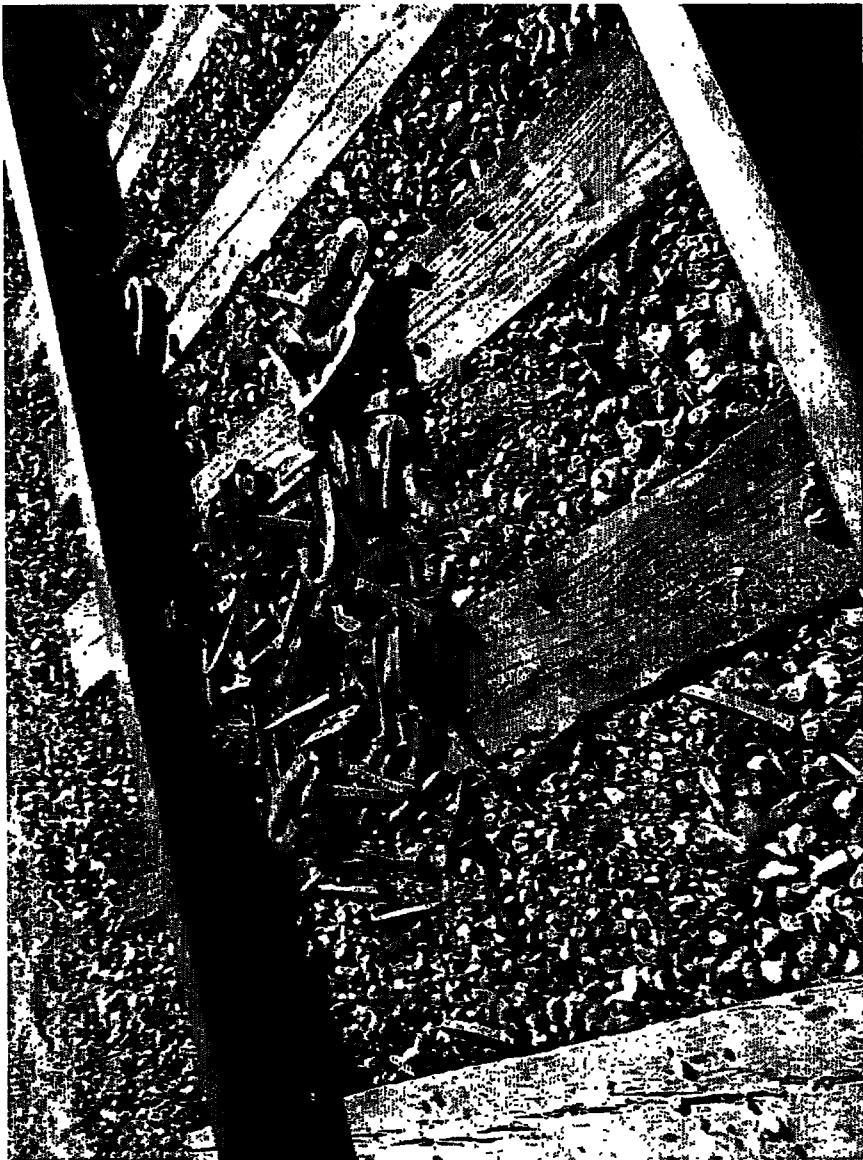
RR Construction Debris

Approximately 30 years north of previous photo. An assortment of old railroad spikes and other assorted debris laden track, when it would appear wise to dispose of in a safe, sanitary, and decent fashion.

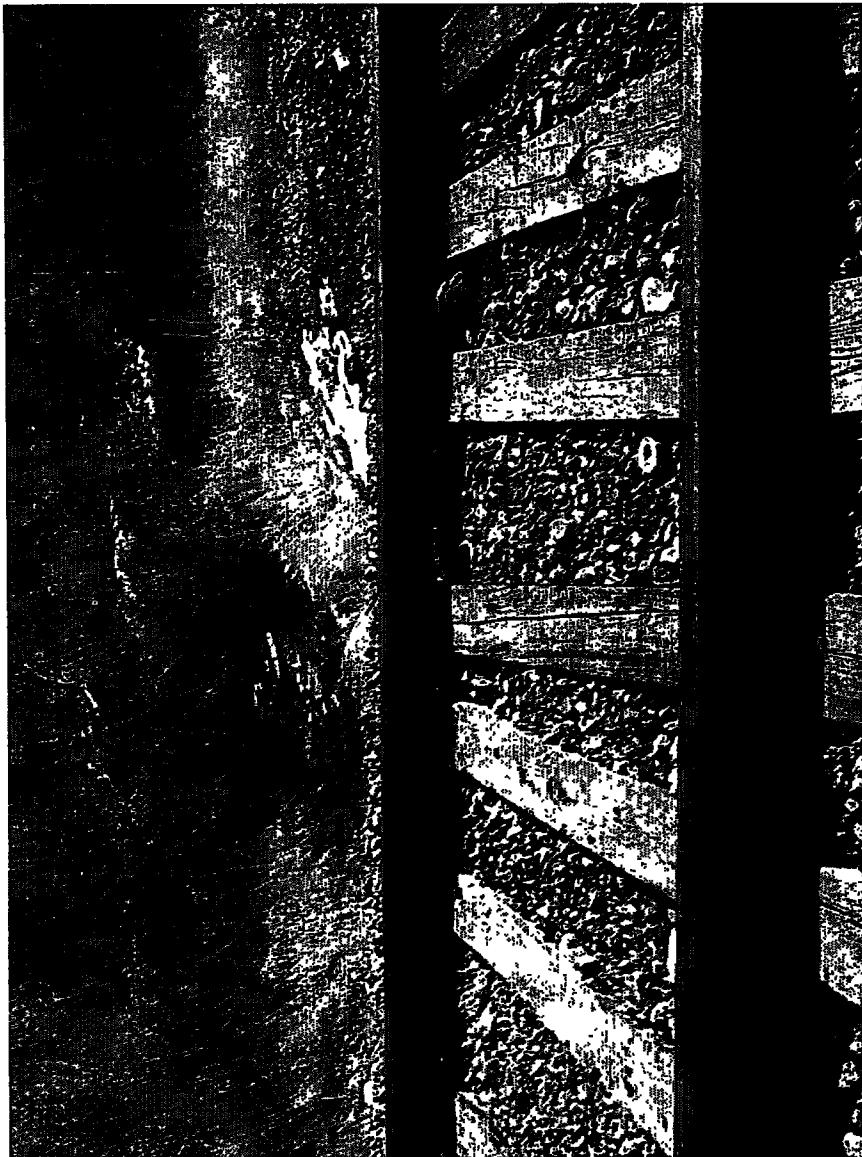
The consistency throughout the system appears to be stressed out railroad ties. This photo suggests that at least three RR ties are fractured to the extent that they should be replaced.
